WINSOR DAM MA 00588
QUABBIN SPILLWAY MA 00589
GOODNOUGH DIKE MA 00590

PHASE I INSPECTION REPORT
NATIONAL DAM INSPECTION PROGRAM

DEPARTMENT OF THE ARMY
NEW ENGLAND DIVISION, CORPS OF ENGINEERS
WALTHAM, MASS. 02154

SEPTEMBER 1978

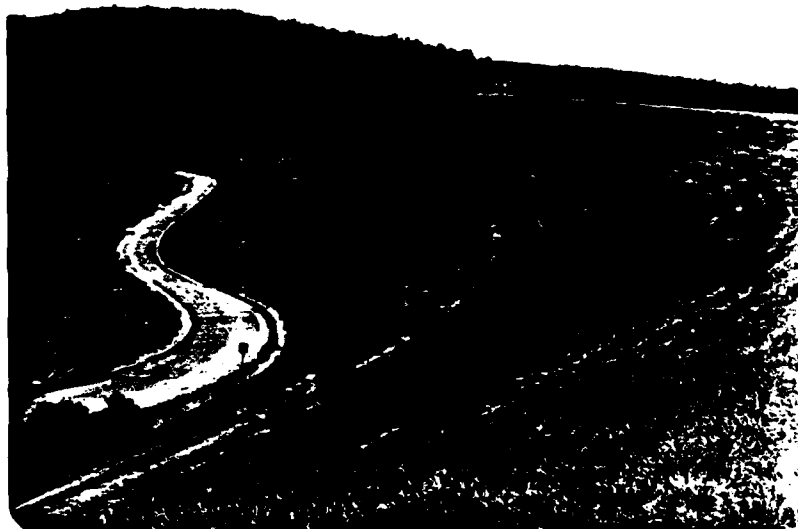
Overview Photo of Winsor Dam
